# C-Start® EMV 6800 Upgrade Manual

This manual was designed to go over the installation of C-Start EMV Reader 6800, including software information done prior to installation, previous hardware removal and EMV settings done in Sierra.

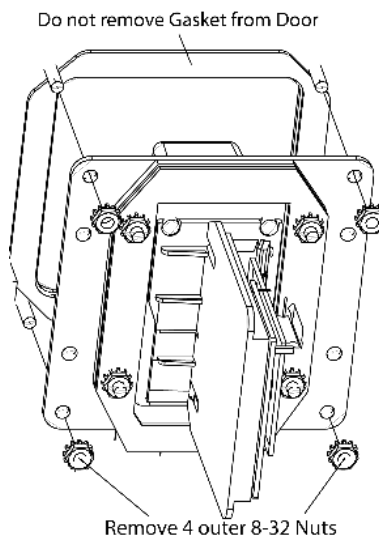
1. Turn Power off to Unit.
2. Open door to Kiosk, locate card reader on the inside of the door, remove the cable connector connecting to the top of the card reader. Tie wrap securely to the harness above the reader slot.
3. Remove the four corner nuts from the rear of the card reader (retaining the plate) with a 11/32 Nut driver.

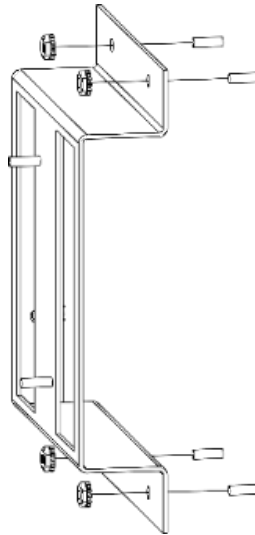
1. On top of the right interior wall, use a 5/16 nut driver to remove the 4 nuts and bracket mounting the modem. Retain the nuts.

Note: Some units may not have the bracket, or the modem may not be mounted inside the bracket. Other units will have No Modem nor bracket because the unit used the Gilbarco Link for Credit card authorization.

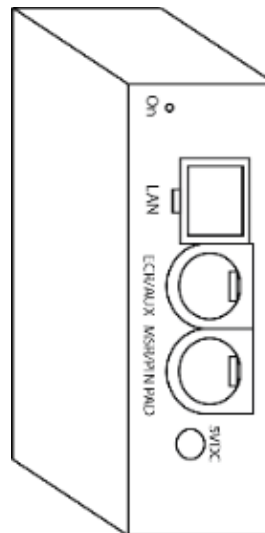
2. The modem should have the LAN (Ethernet) connection removed and the remaining cables left connected. If there is a label covering the MSR/Pin pad connection, you will need to remove it.

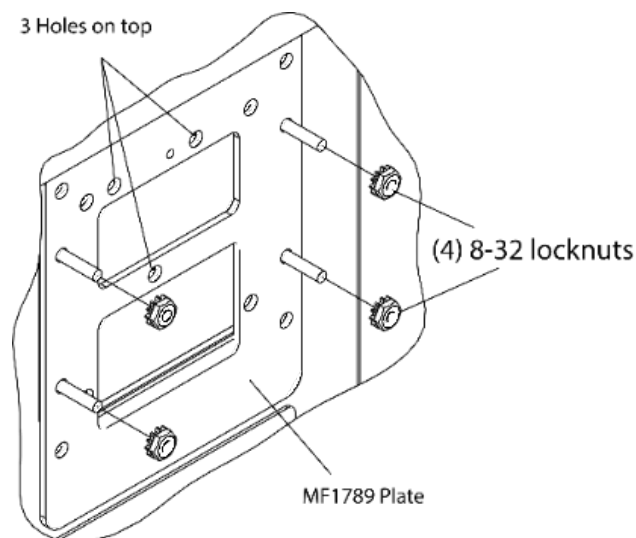
1. Locate MF1789 plate. This is the metal plate that does *not* have the 3 studs protruding from one side.
2. Place the plate onto the 4 studs on the rear door that match up with the 4 outer mounting holes. The side of the plate that says, "THIS SIDE TOWARD DOOR" should be placed facing the door. There should be more holes on the top of the plate than on the bottom of the plate.
3. Secure the plate to the door using (4) 8-32 Locknuts and an 11/32 Nut Driver.

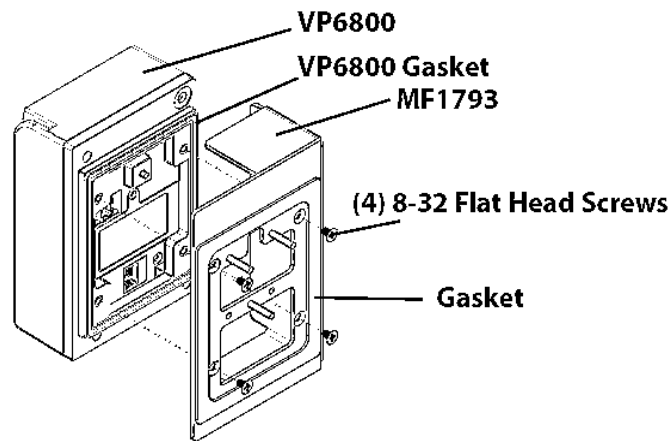
5. Locate the MF1793 bracket (side impact bracket). This will have 3 studs sticking out and a gasket mounted onto the back side with the studs.
6. Install MF1793 bracket onto rear of the VP6800 EMV reader using (4) 8-32x3/4" Flat Head Stainless Steel screws and a #2 Phillips head screwdriver. DO NOT USE the 4 pan head screws that came in the reader box. The three mounting studs that stick out should be on the TOP half of the plate facing the rear. If installed correctly, you should be able to see the RJ45 network jack as well as the white 2x6 Power/Serial Jack on the back of the VP6800.

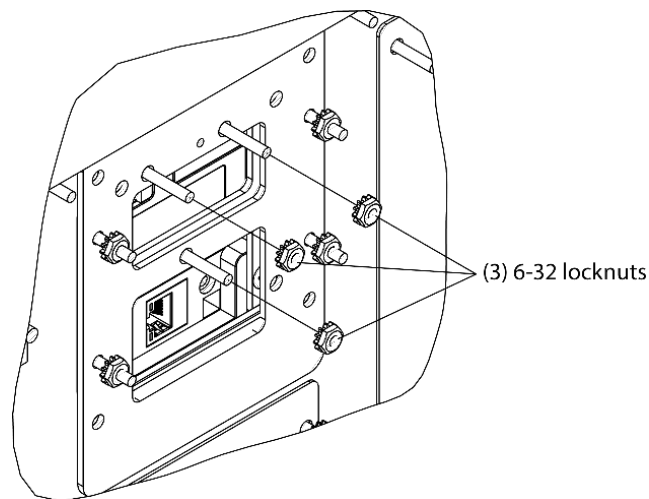
7. Insert the VP6800 reader from the front of the door so that the 3 studs of the MF1785 go through the matching holes on the top half of the MF1789. Secure studs to MF1789 using (3) 6-32 nuts and a 5/16" nut driver. Verify all (4) 8-32 Nuts and (3) 6-32 nuts are secure.

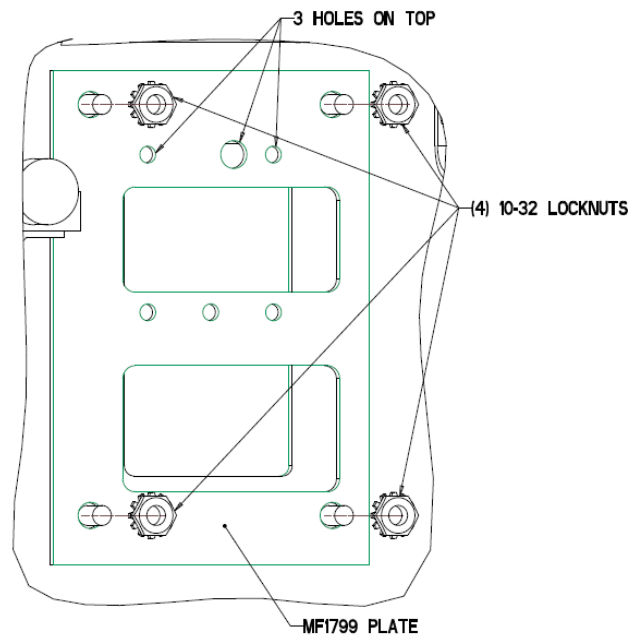
1. Locate MF1799 plate. This is the metal plate that does NOT have the 3 studs protruding from one side.
2. Place the plate onto the 4 studs on the rear door that match up with the 4 outer mounting holes. The side of the plate that has the part number marked should be faced towards you. There should be more holes on the top of the plate than on the bottom of the plate.
3. Secure the plate to the door using (4) 10-32 Locknuts and an 3/8 Nut Driver.

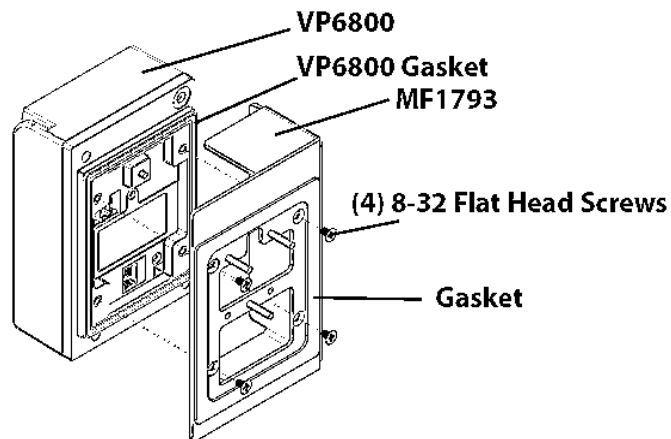
5. Locate the MF1793 bracket (side impact bracket). This will have 3 studs sticking out and a gasket mounted onto the back side with the studs.
6. Install MF1793 bracket onto rear of the VP6800 EMV reader using (4) 8-32x3/4" Flat Head Stainless Steel screws and a #2 Phillips head screwdriver. DO NOT USE the 4 pan head screws that came in the reader box. The three mounting studs that stick out should be on the TOP half of the plate facing the rear. If installed correctly, you should be able to see the RJ45 network jack as well as the white 2x6 Power/Serial Jack on the back of the VP6800.

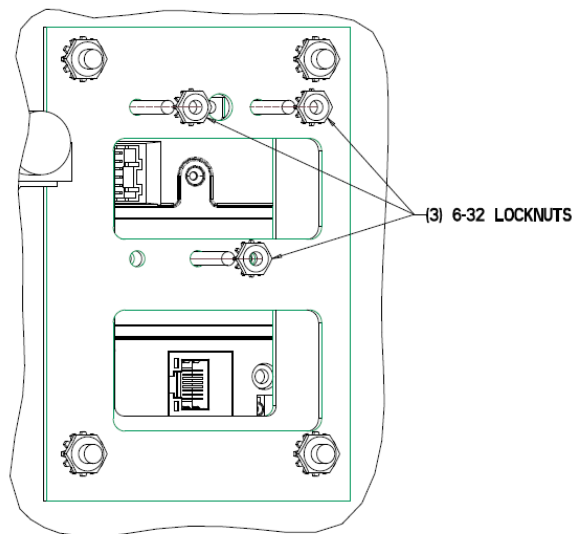
7. Insert the VP6800 reader from the front of the door so that the 3 studs of the MF1785 go through the matching holes on the top half of the MF1799. Secure studs to MF1799 using (3) 6-32 nuts and a 5/16" nut driver. Verify all (4) 10-32 Nuts and (3) 6-32 nuts are secure.

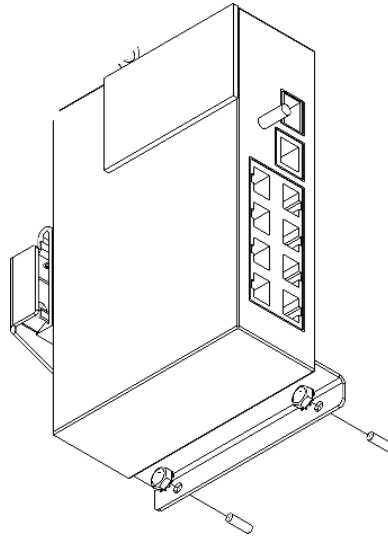
1. Secure the Network Switch plate assembly onto the upper right interior wall using the bottom 2 studs. Use (2) 6-32 nuts and a 5/16 open end wrench to tighten.

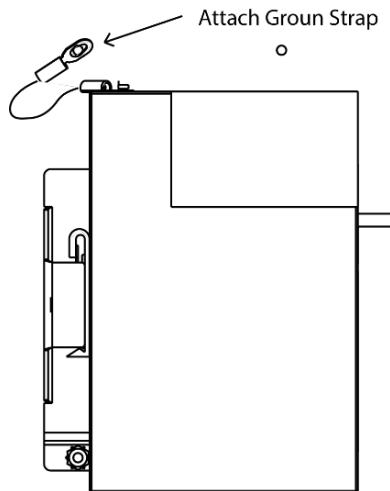
2. Secure the grounding wire to the rear top stud above it using a 6-32 nut and a 5/16" nut driver onto one of the top two nuts above the switch assembly.

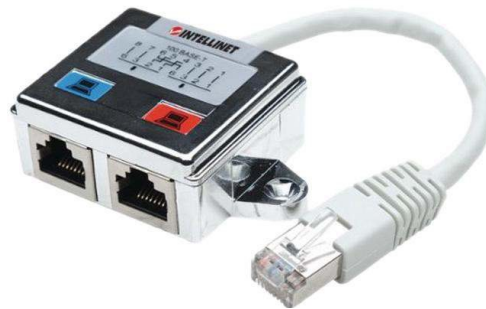
Ethernet splitter

1. If there is currently an Ethernet Splitter installed that turns one Ethernet line into two, you **MUST** remove the splitter from both sides of the line. Remove the splitter from inside the C-start cabinet and the C-store/Network room. If a splitter is installed, it may look like the image shown below or similar.
2. If there are 2 separate Ethernet runs, you will simply need to hook one up to the Routers Green Box Jack.

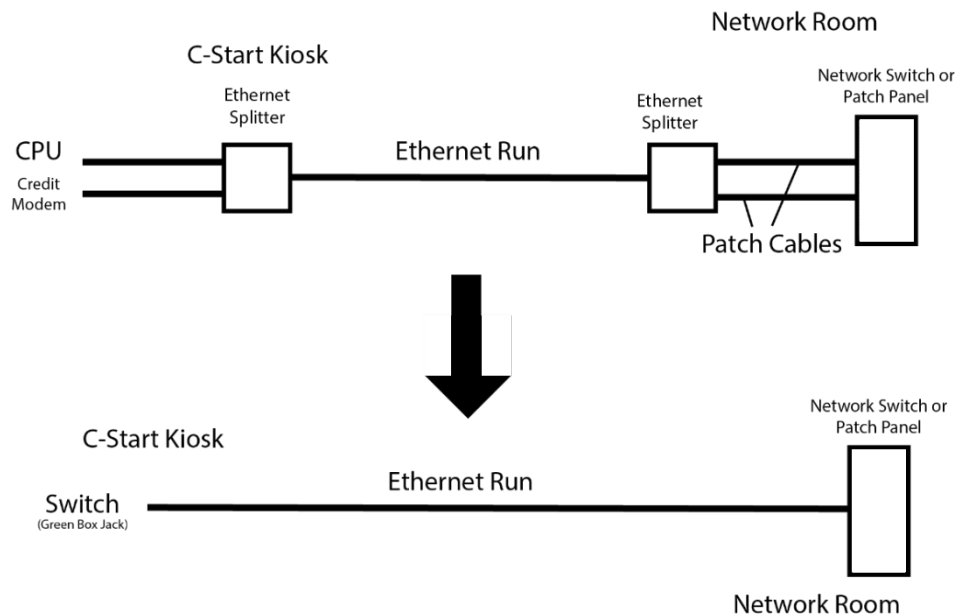
3. Plug the single Ethernet Cable back into the Router in the C-store and the Single Ethernet cable into the Green Boxed Jack on the Switch installed into the C-start.

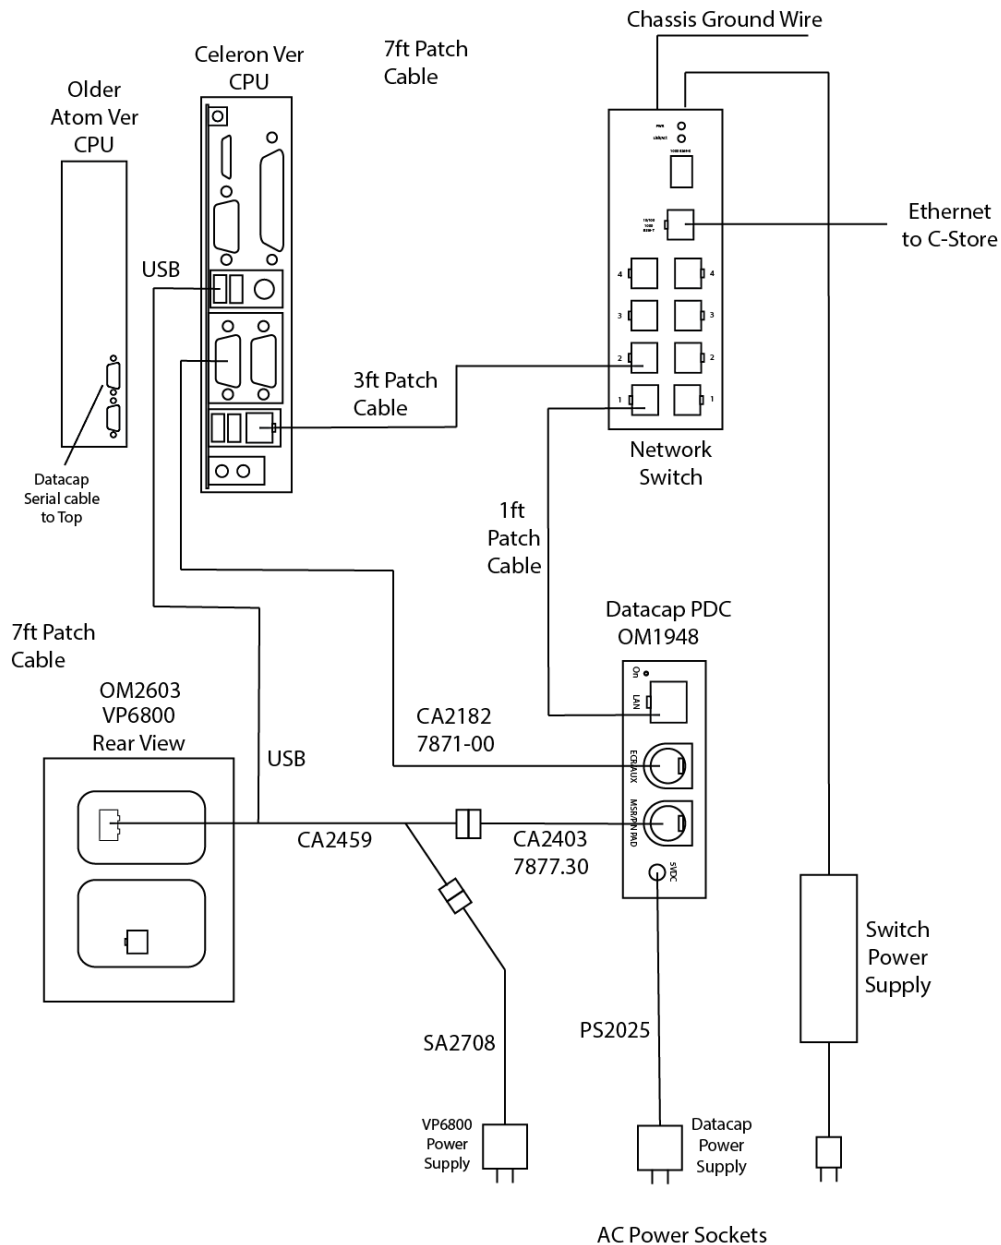
VP6800 EMV Connection Diagram  
Cstart or Sentinel

Follow the Diagram below to connect the remaining cables. If there are two Ethernet cables going back to the C-Store, you should only connect one into the Switch. Follow the Cable Routing guide on the following page. (Note: If your kit was shipped with two 7 foot patch cables, you may substitute that cable for a 3 foot patch cable.)

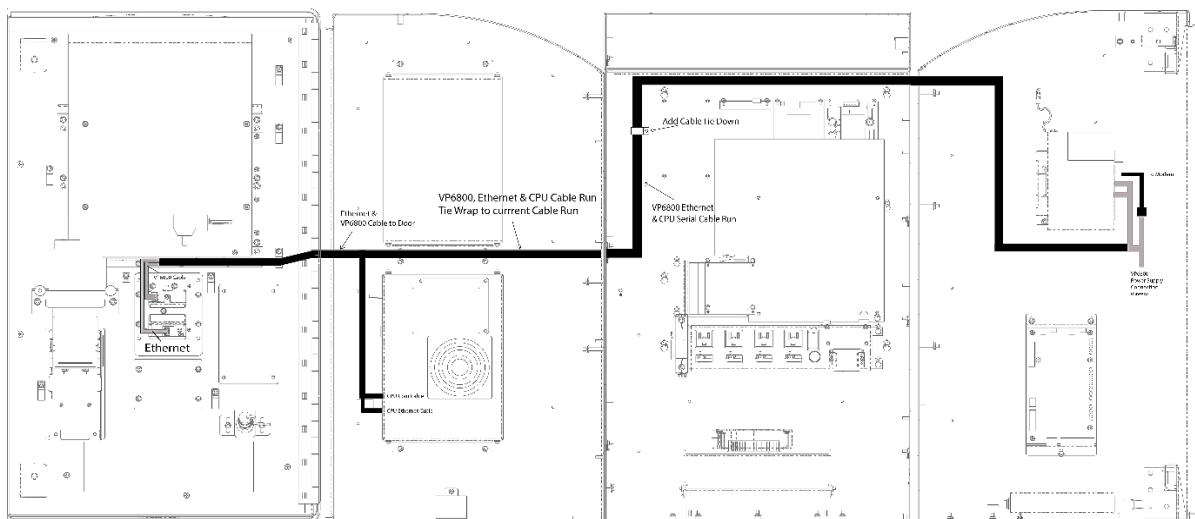
Follow the diagram and steps below for the best routing of cables.

1. Use the tie wraps included in your kit to tie the new cables to the existing cable runs.
2. Make sure the cable that runs along the door hinge is able to move freely. The cable should be tie wrapped on both sides of hinge so that opening and closing door does not flex or pinch the connectors going to the VP6800 EMV reader.

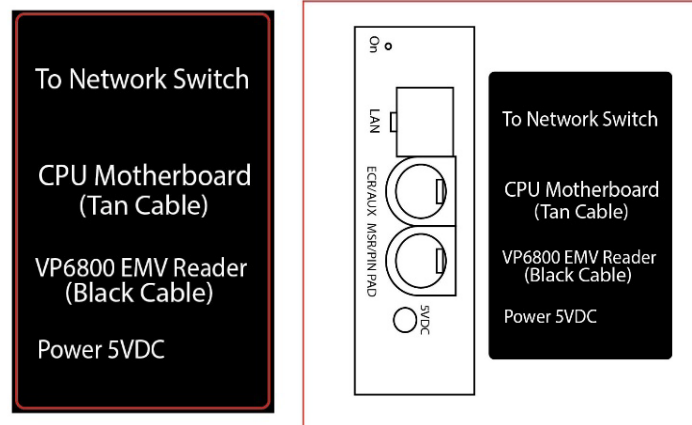
1. Place the smaller black label on the side of the Datacap Modem. Make sure the text for “To Network Switch” aligns with the RJ45 Network Jack.
2. Place the larger label on the right wall of the cabinet. The label should be visible near the Modem.

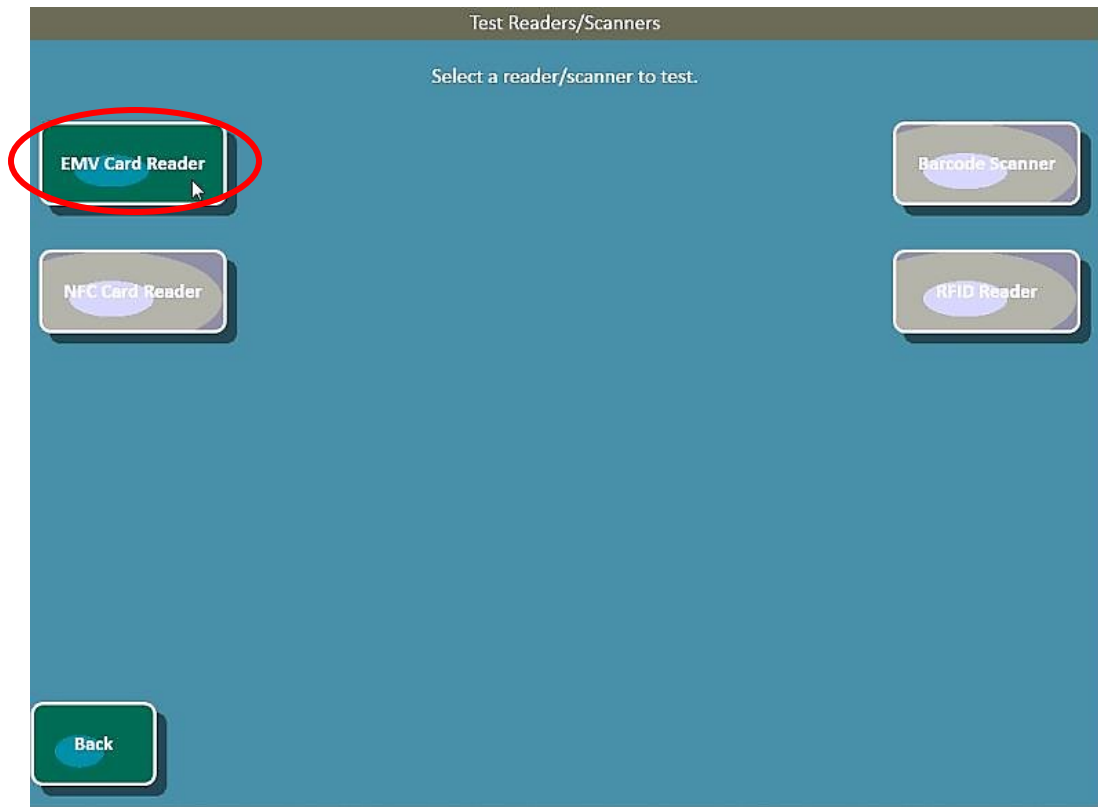
Tran EMV Card Reader Test

4. Version should show on the top left as "IPE EMV CLIENT RENTAL VER: 4.xx SL"

**IPE EMV CLIENT RENTAL VER: 4.28 SL**
